Tribal Road Safety Audits: **CASE STUDIES**

FHWA-SA-08-005

1. Report No. FHWA-SA-08-005		2. Government Accession No.		3. Recipient's Catalog No.	
4. Title and Subtitle <i>Tribal Road Safety Audits: Case Studies</i>				5. Report Date September 2008

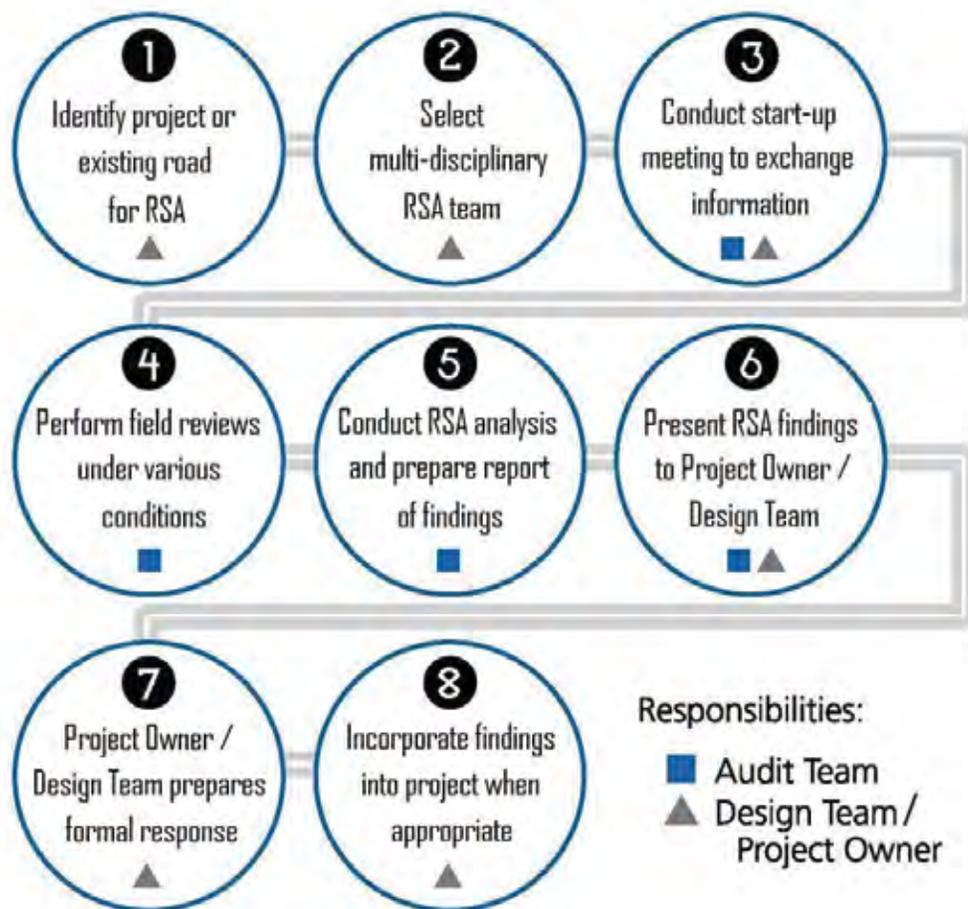
FIGURE 1 RSA PROCESS

The eight steps of an RSA are shown in Figure 1, and are discussed below with reference to the case studies.

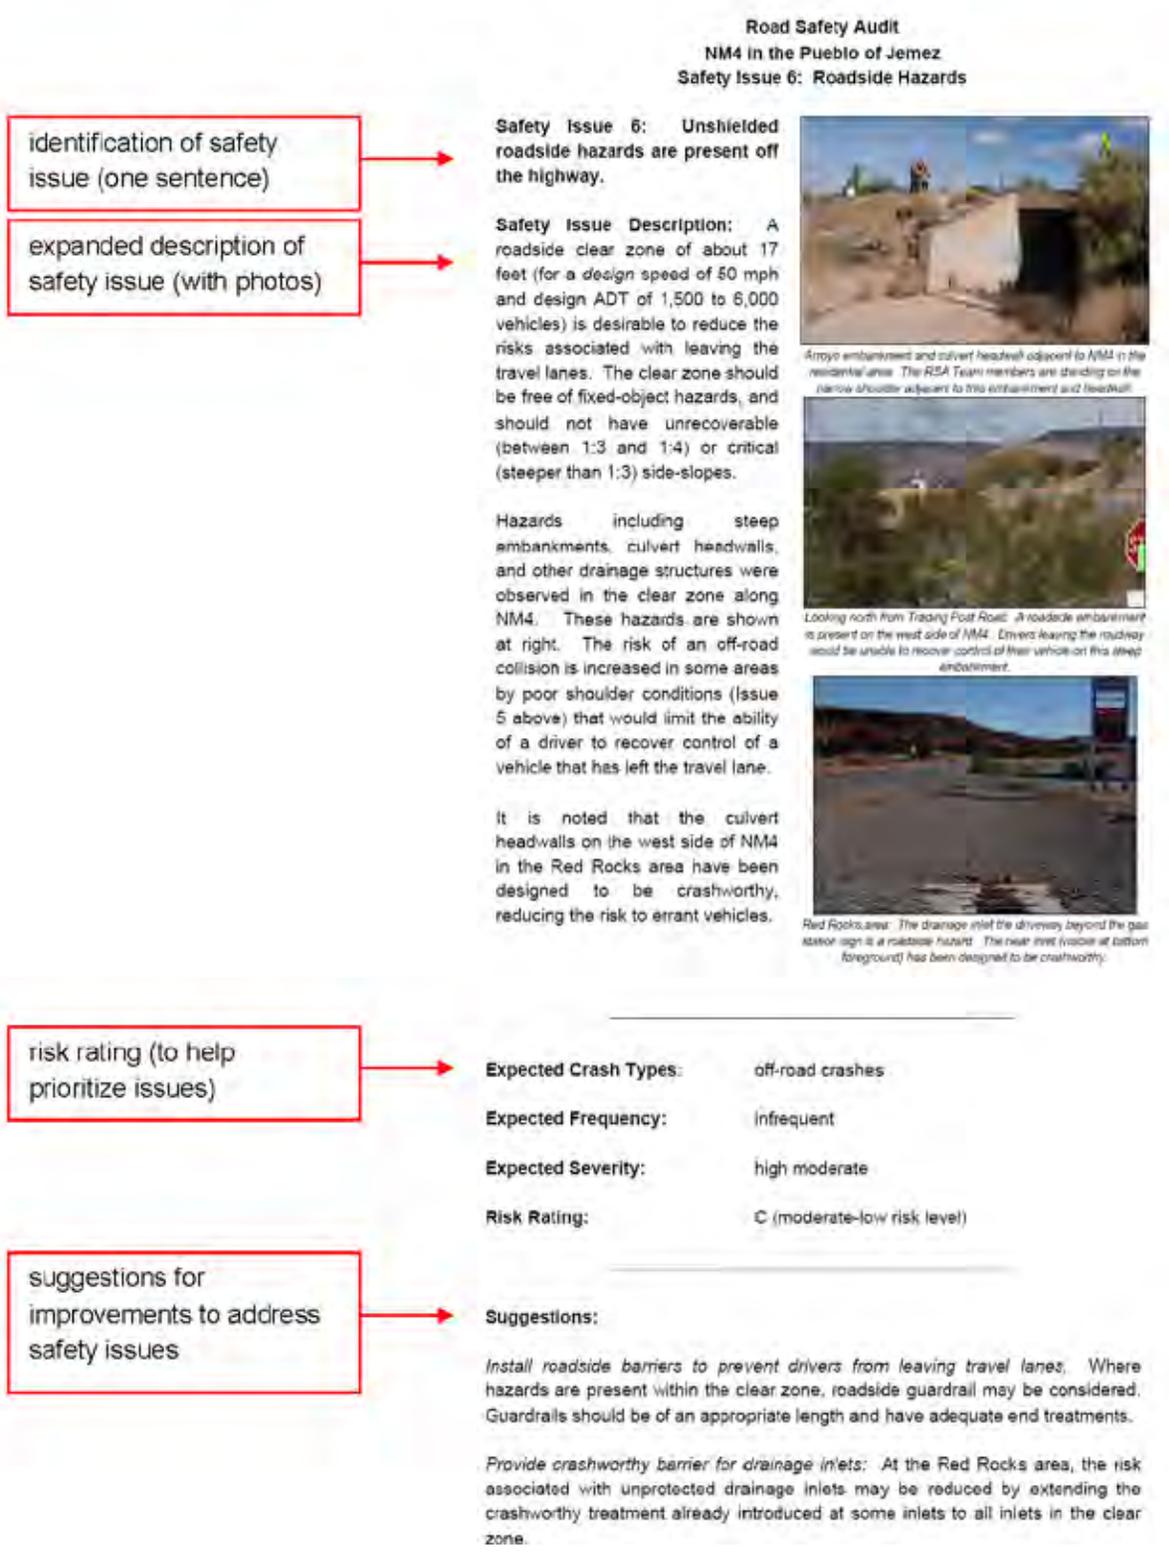
FIGURE 6 EXAMPLE DISCUSSION OF AN RSA SAFETY ISSUE

At the RSA start-up meeting, a frank discussion of the constraints and challenges encountered in the design of the project, or operation of existing road, is critical to the success of the RSA. It is crucial that the RSA team understand the trade-offs and compromises that were a part of the design process or the form of the present road. Knowledge of these constraints helps the RSA team to identify mitigation measures that are practical and reasonable.

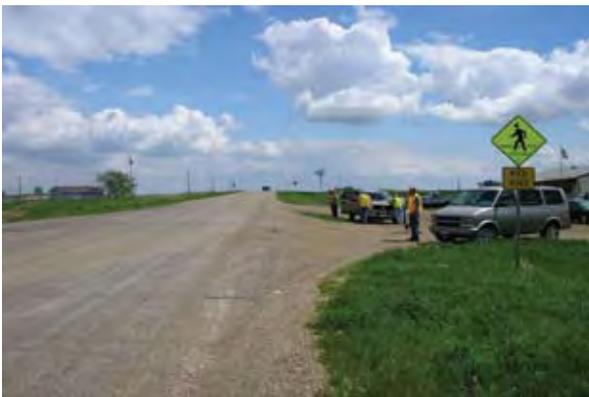
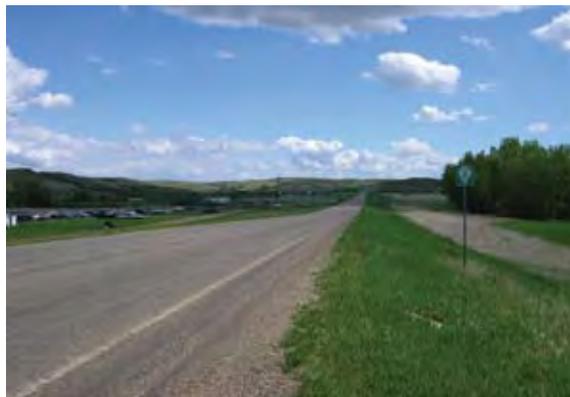
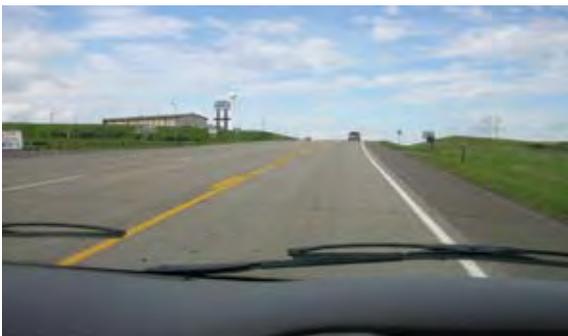
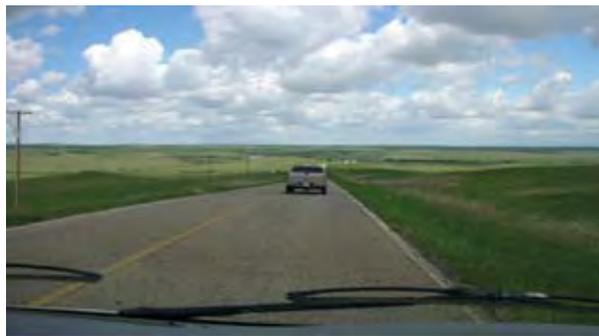
FIGURE A.1 VIEWS OF RSA SITES (STANDING ROCK SIOUX TRIBE RSA)

Roads studied during this RSA included ND 24 and Highway 1806 (part of BIA 3), US 12, and community access roads. Typical reservation roadways are shown in Figure A.1. The RSA team drove these roads to identify safety issues associated with road geometry, traffic operations, and maintenance. Although bridge inspection is not a usual part of the RSA process, the RSA team was asked to observe possible maintenance issues associated with a bridge on BIA 3 at Four-Mile Creek. RSA findings associated with the bridge were included in the RSA report.

BIA 3 at intersection with ND 24 south of Fort Yates, ND

BIA 3 / Hwy 1806 in Kenel, SD

US 12 at Grand River Casino (left), near Mobridge, SD

BIA 44 west of Mahto, SD

SELECTED SAFETY ISSUE (Number and Description)		RISK RATING	SUGGESTIONS
1	<i>Road Maintenance:</i> Limited maintenance on reservation roads contributes to poor pavement conditions and concern regarding bridge stability.	B to D	<ul style="list-style-type: none"> • control cracking with sawcut and fill • accommodate future overlays • bridge inspection and repair
2	<i>Access to Grand River Casino:</i> Drivers turning into and out of the Grand River Casino may interfere with crossing, opposing, and following traffic on US12.	D	<ul style="list-style-type: none"> • speed reduction • improved signing • westbound left turn bay • access relocation
3	<i>BIA 31 and ND 24 (School Frontage):</i> Driver workload is potentially high near the intersection of BIA 31 and ND 24, which accommodates local, school, and through traffic.	B to D	<ul style="list-style-type: none"> • no-passing zone • crosswalk maintenance • enhanced signing • turning lanes on ND24 • improved lighting • access consolidation • urban cross section

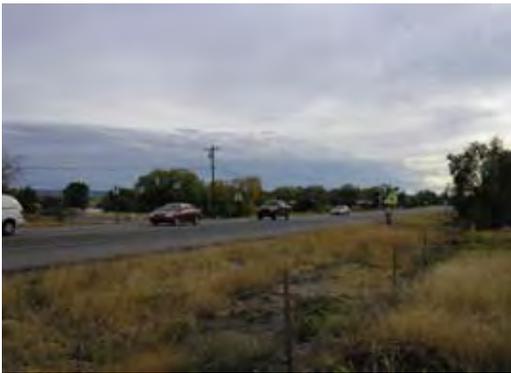
FIGURE A.2 VIEWS OF RSA SITE (THE SANTA CLARA PUEBLO)

Looking south along NM 30 toward a signed and marked school zone crosswalk near the Pueblo's main residential area.

SAFETY ISSUE (Number and Description)		RISK RATING	SUGGESTIONS
5	<i>Lighting:</i> The absence of overhead lighting limits the visibility and conspicuousness of unsignalized intersections and the school crosswalk.	B	<ul style="list-style-type: none"> • install lighting at signed entrances to Pueblo • install lighting at school crosswalk
6	<i>Roadside Hazard:</i> Two signal poles are located within the clear zone at a signalized intersection.	C	<ul style="list-style-type: none"> • provide a roadside barrier
7	<i>Speed Limits:</i> <ul style="list-style-type: none"> • Frequent speed limit changes may result in unintentional violations and differential speeds. • Speeds limits may be high adjacent to the main residential area. 	C	<ul style="list-style-type: none"> • review speed limits

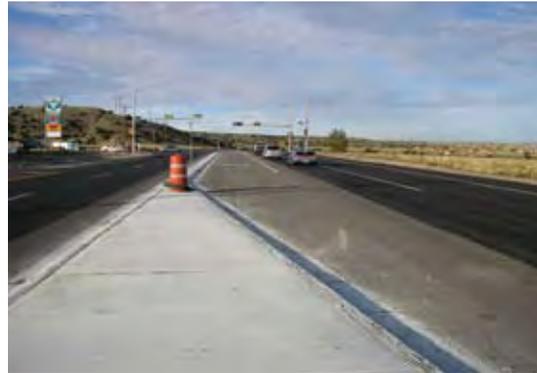
Looking north along NM 30 toward a recently improved intersection adjacent to a convenience store/gas station. The full traffic signal was in place, but not operational, at the time of the audit.

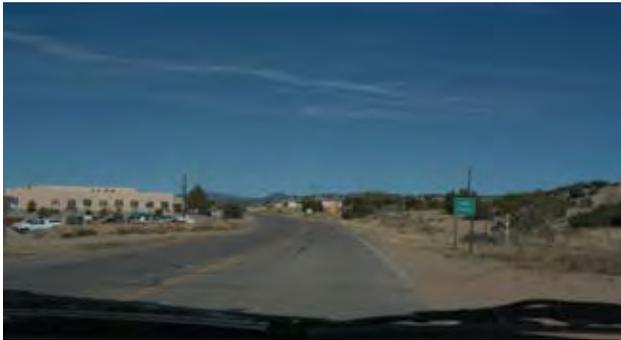
FIGURE A.3 VIEWS OF RSA SITE (THE JEMEZ PUEBLO)

Looking north along NM 4 at the entrance to the Pueblo of Jemez. NM 4 is predominantly a two-lane rural road with wide shoulders, with a speed limit of 30 mph along this segment.

SAFETY ISSUE (Number and Description)		RISK RATING	SUGGESTIONS
2	<i>Pedestrian Safety:</i> Pedestrians walking along NM 4 have no dedicated pedestrian facilities.	D	<ul style="list-style-type: none"> • network of continuous off-road paths • improved visibility at school bus stops • lighting in areas of potential vehicle/ pedestrian conflicts • marked pedestrian crossings • reduced speed limit (Red Rocks recreational area) • access management plan
3	<i>Signing, Pavement Markings, and Delineation:</i> Missing signs, pavement markings, or delineation may limit driver guidance and increase the risk of collision. Excessive signing may distract drivers.	C	<ul style="list-style-type: none"> • comprehensive signing review • improved pavement markings
4	<i>Speed:</i> Speeds above the posted speed limit increase the risk and potential severity of crashes on NM 4.	E	<ul style="list-style-type: none"> • gateway treatment • speed display signs • consistent speed limit (Red Rock recreational area) • pavement word markings • review of need for transitional speed zone

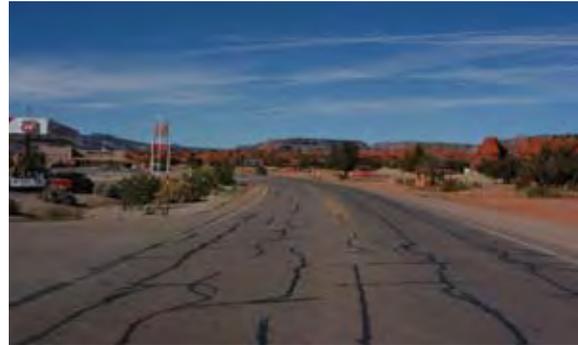
Looking north along NM 4 at the Red Rocks recreational area. Roadside land uses include the commercial area (service station and Walatowa Visitors Center) visible at left, and the recreational area (where small-scale vending takes place during the summer) at right. The speed limit along this segment of the highway is 50 mph.

5	<i>Deterioration of Shoulder:</i> Shoulder conditions may deteriorate as a result of surface drainage flows and traffic.	C	<ul style="list-style-type: none"> • shoulder stabilization • curb and gutter
6	<i>Roadside Hazards:</i> Unshielded roadside hazards are present off the highway.	C	<ul style="list-style-type: none"> • roadside barriers • crashworthy drainage inlets
7	<i>Intersection with Bear Canyon Road:</i> Limited sight distances, especially at night, increase the risk of collision at this intersection.	C	<ul style="list-style-type: none"> • improved signing and pavement markings • lighting • transverse rumble strips • pedestrian improvements
8	<i>School Bus Operations:</i> School buses do not consistently operate their flashing lights when picking up and dropping off students.	D	<ul style="list-style-type: none"> • clarification of policy • lighting at school bus stops

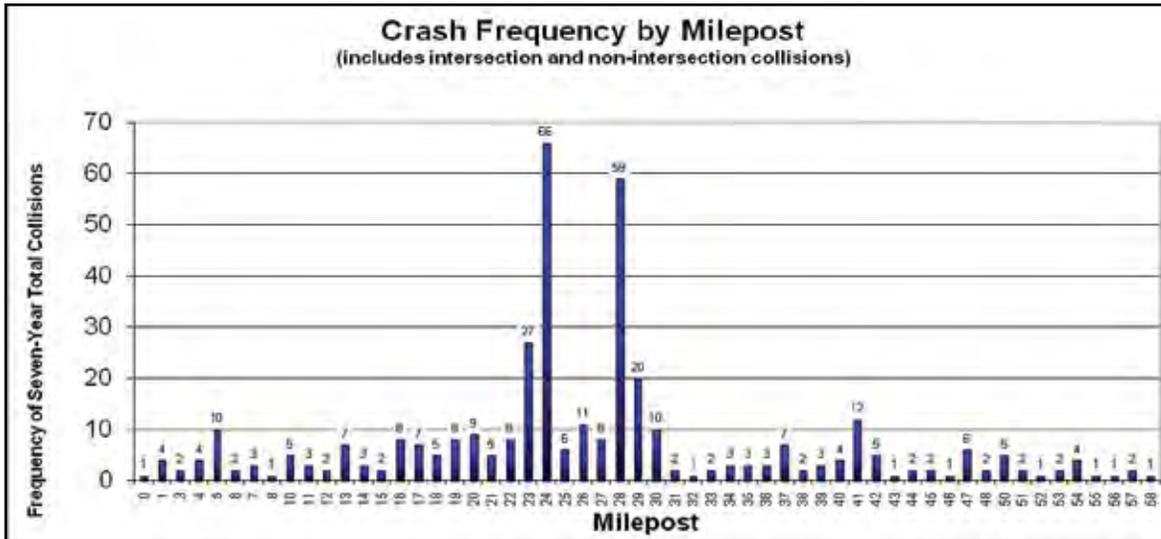
FIGURE A.4 COLLISIONS ALONG HIGHWAY N-12

Seven years (1999 through 2005) of collision summaries along N-12 were reviewed as part of this RSA. Over seven years, a total of 386 collisions were reported along N-12. Annual collision frequency peaked in 2002 with 60 reported collisions, and declined each

subsequent year to a low of 21 reported collisions in 2005. Figure A.5 shows the spatial distribution of collisions along the entire highway segment from MP 0.0 to MP 58.5. Peaks are evident around MP 23/24 and MP 28/29, which correspond to the Window Rock and Fort Defiance areas.

NOTE: Shows collision locations reported on N-12 over seven years (1999 through 2005). Distribution is shown in one-mile segments, so (for example) all collisions at MP 24.0 through 24.9 are shown at “MP24” in the chart.

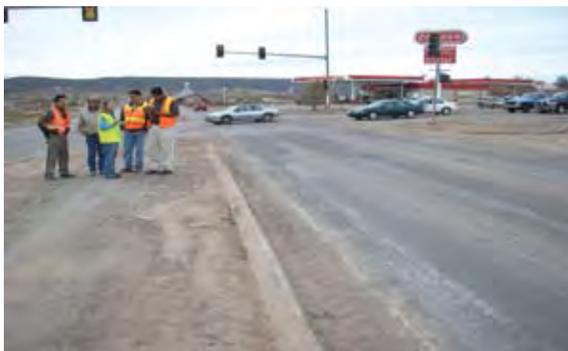
FIGURE A.5 VIEWS OF RSA SITE (NAVAJO NATION)

Looking north along N-12 at the intersection with N-110 (near Fort Defiance). A 62-foot urban cross-section is provided, consisting of two through lanes in each direction, with curb and gutter and turn lanes (or a raised median) at intersections.

SAFETY ISSUE (Number and Description)		RISK RATING	SUGGESTIONS
5	<p><i>Intersection of N-12 and N-110 (Fort Defiance):</i></p> <ul style="list-style-type: none"> • The intersection configuration and conspicuousness may be limited. • Movements at driveways near the intersection may contribute to conflicts. • A fixed-object hazard is located close to travel lanes. • Laning on the east exit leg is not clear. 	C	<ul style="list-style-type: none"> • improve signing and pavement markings • upgrade the signal display • review opportunities for access management • upgrade the east exit leg
6	<p><i>N-12 near St Michael's School (between MP22 and MP23):</i></p> <ul style="list-style-type: none"> • Horizontal and vertical curves limit sight distance on the approaches to the school driveway. • Roadside hazards may increase the potential risk and severity of an off-road collision. 	C	<ul style="list-style-type: none"> • improve signing around the school driveway • increase the length of the guardrail • improve curve delineation

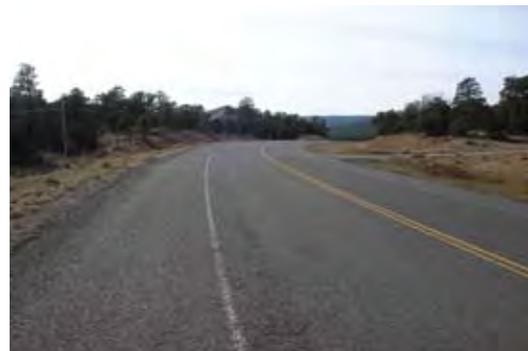
Looking south along N-12 at audit site south of Highway 264. The cross-section is a two-lane rural road with wide paved shoulders.

SAFETY ISSUE (Number and Description)		RISK RATING	SUGGESTIONS
1	<i>Signing and Pavement Marking:</i> Worn or missing signs and pavement markings may limit driver guidance, especially at night.	D	<ul style="list-style-type: none"> • policy measures • measures to improve visibility and reduce maintenance requirements
2	<i>Pedestrian Facilities:</i> The design and maintenance of some pedestrian facilities may limit their usefulness. Pedestrians who are unable or unwilling to use pedestrian facilities may use the roadway instead, where they are exposed to vehicle traffic.	D	<ul style="list-style-type: none"> • maintenance schedule review • completion of pedestrian networks with sidewalk segments and marked crosswalks (where currently missing) • removal of obstructions in sidewalk
3	<i>Poor Pavement Conditions:</i> Cracked, worn, rutted, and dusty/muddy pavement may reduce driver control (especially for motorcyclists), particularly on N-12 between N-110 and Hwy 264.	C	<ul style="list-style-type: none"> • pavement repair and rehabilitation
